New York State Department of Transportation

PIA Safety Flag NB23CTW005

BIN: 1065318

Feature Crossed: 6TH AVENUE

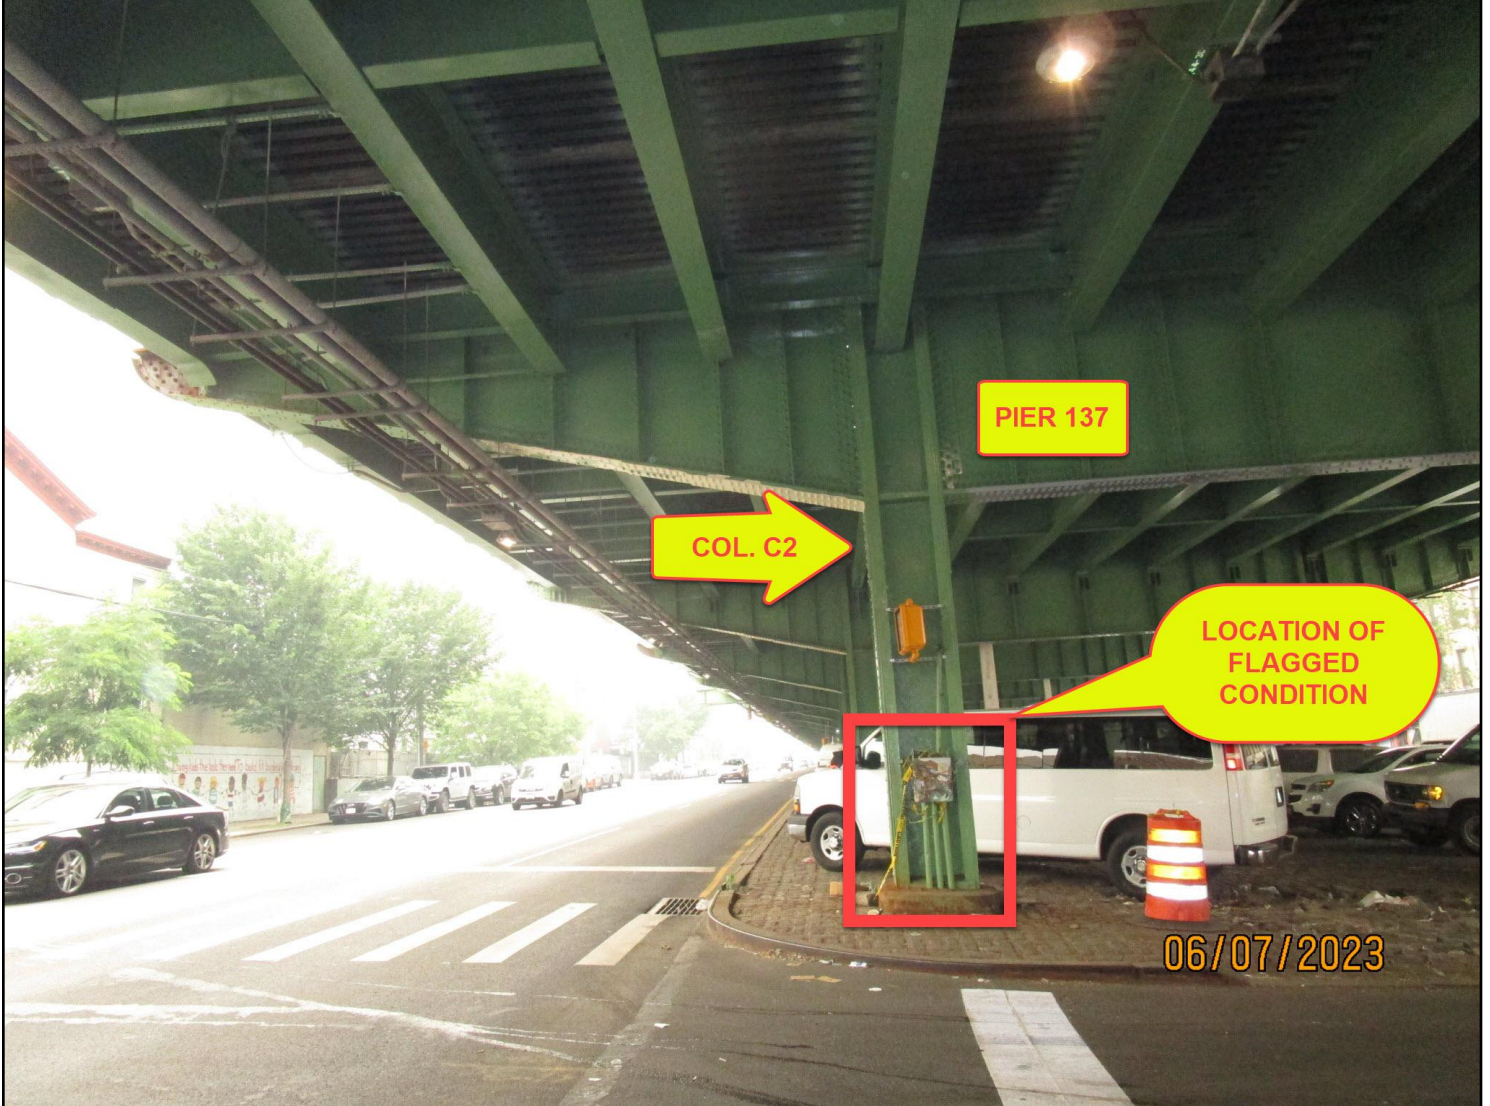
Photo Number: 2

Attachment Description: General view of Flagged location. Looking Begin.

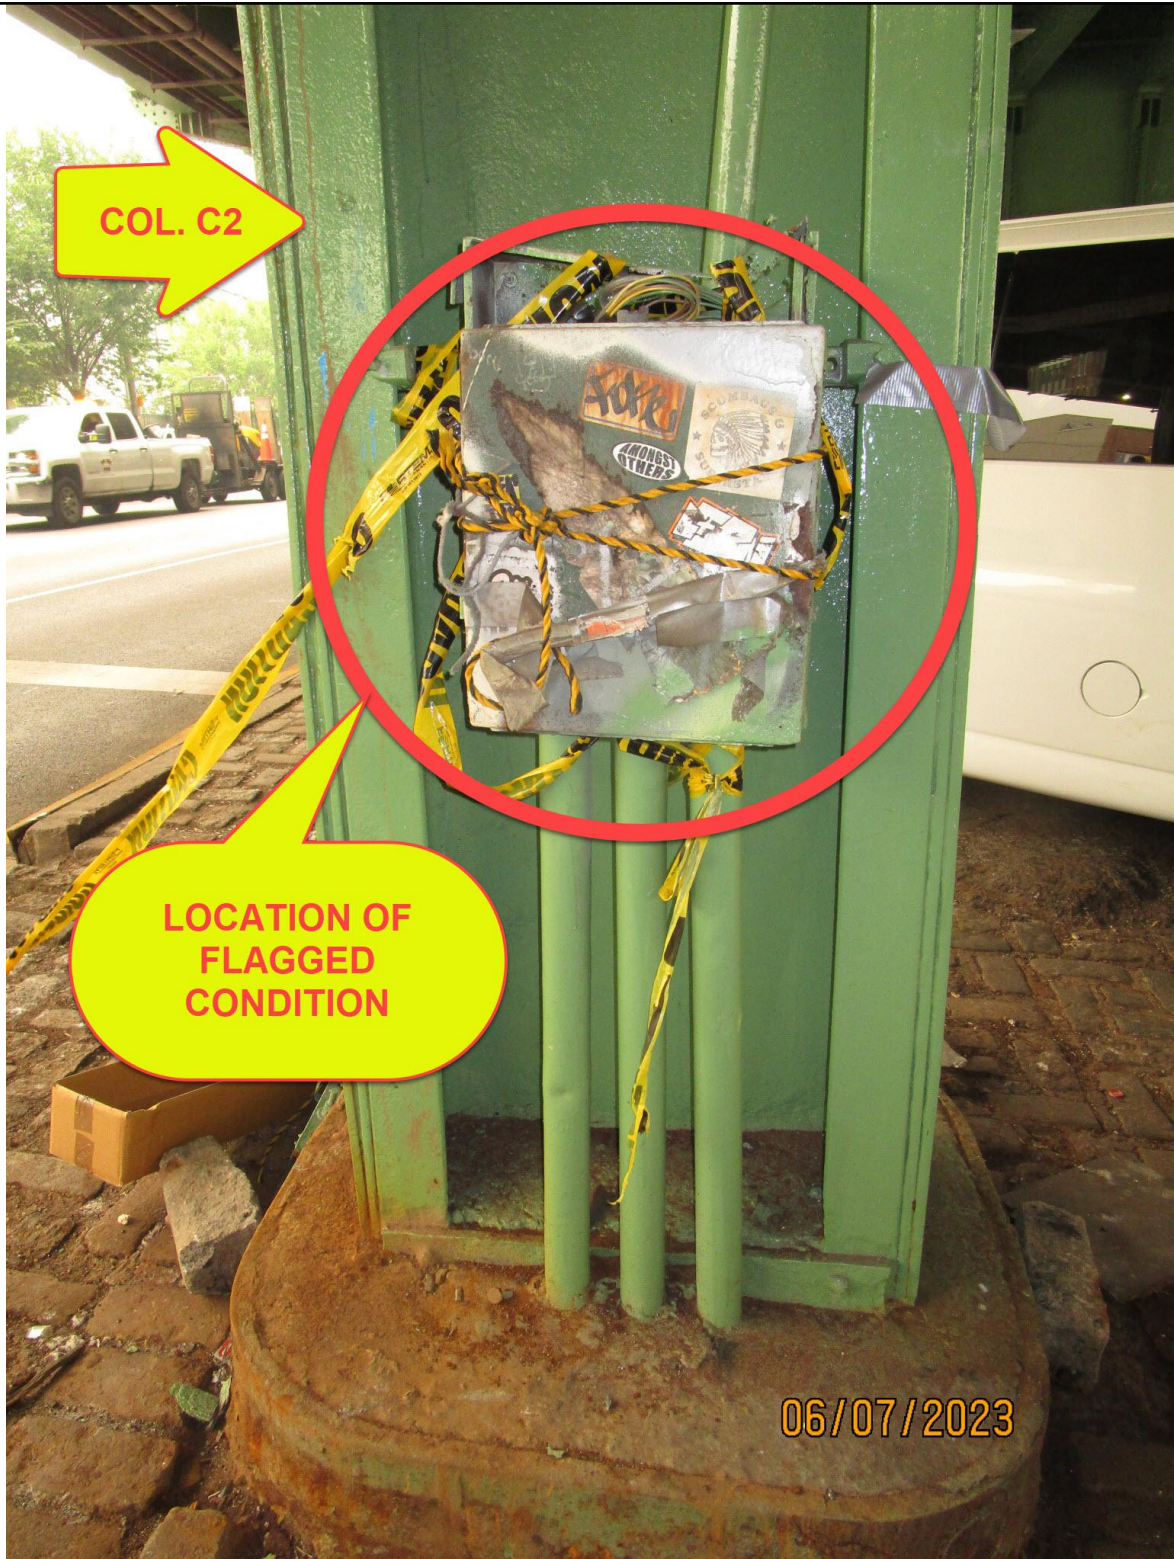
Photo Number: 3

At Span 138, Pier 137 Column C2, End face, there is a corroded and broken electrical junction box which exhibits exposed live wires. The condition is at the base of the column, and is accessible by the public.

Attachment Description: Location of Flagged condition at Pier 137, Column C2. Looking Begin.

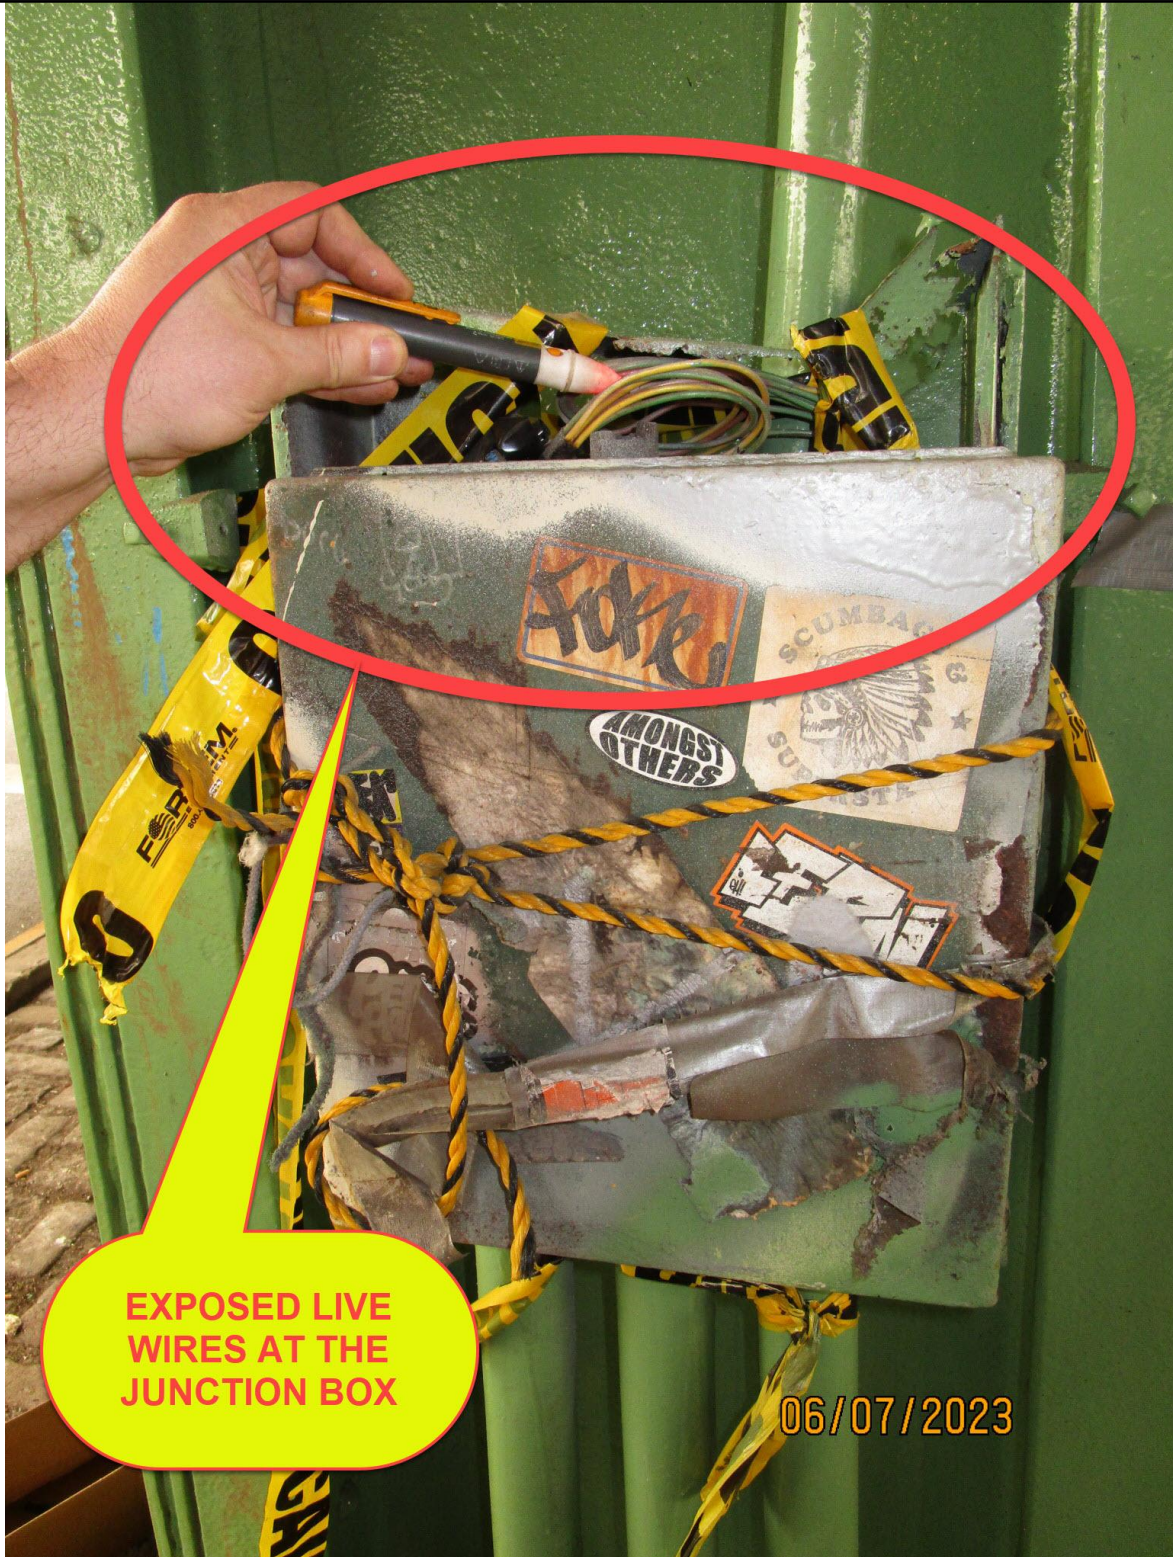
Photo Number: 4

**EXPOSED LIVE
WIRES AT THE
JUNCTION BOX**

Attachment Description: Close-up view of the junction box with exposed live wires. Looking Begin.
